Advanced Management Module
Messages Guide

Fourteenth Edition (October 2014)

Chapter 1. Introduction

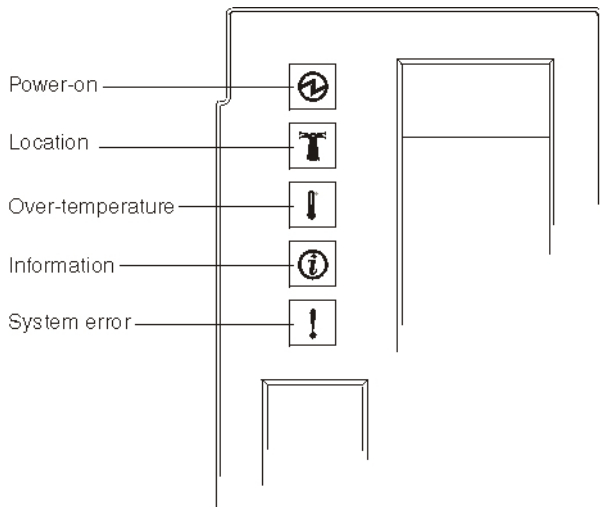
For example, on a BladeCenter S chassis, the following system LEDs are displayed on the media tray:

View the system LEDs remotely through the advanced management module Web interface. The main LED page shows the external LEDs on the chassis panels and the front panel. The internal blade LEDs are also available through a blade hyperlink from the LED page. This enables you to see the status of the internal LEDs on the blade server without having to turn off the blade server, remove it from the chassis, and activate the light path indications.

The chassis LEDs indicate the status of the components in the chassis. For example, if the error, information, temperature, or location LED is lit for a blade server, the same LED will be lit on the system LED panel for the chassis. The information and location LEDs can also be turned off remotely, but you might need to turn off the LED on the blade for the request to be accepted.

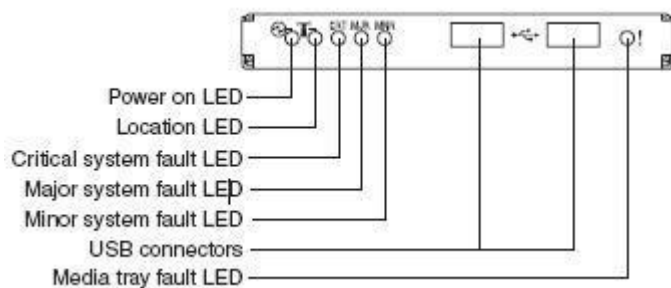
Light path diagnostic LEDs - BladeCenter T and BladeCenter HT chassis

The system LEDs are displayed on the media tray.

The following system LEDs are displayed:
